Failure Analysis of the Clutch Brake System in a 400-ton Hyundai Stamping Press

Muhammad Firdausi¹, Rafie Safa Mahendra²

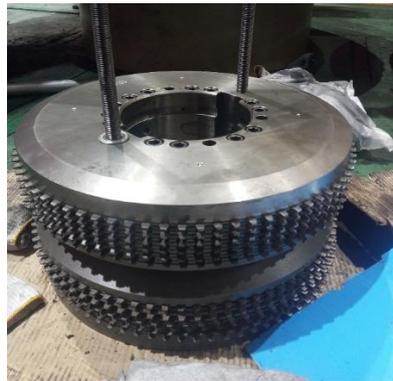
Figure 1. Clutch Brake

During inspection, it was identified that the lubrication distribution system of the stamping press was not functioning properly. Lubricating oil from the reservoir was not adequately supplied to the clutch brake unit, resulting in insufficient lubrication. This condition accelerated wear of internal components and contributed to hydraulic leakage, ultimately leading to clutch brake failure.

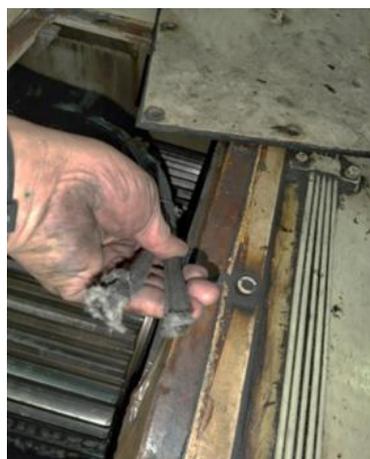
Figure 2. Hydraulic hose before repair

The hydraulic hose was found to be damaged due to being pinched by the main drive gear (Figure 2). This mechanical interference caused localized stress concentration, leading to hose rupture and sudden loss of hydraulic pressure. As a corrective action, the damaged hose was replaced and rerouted to prevent direct contact with rotating components (Said, 2023; Nasution & Lukman, 2024). This repair restored proper hydraulic flow and improved the overall operational reliability of the stamping press (Figure 3).

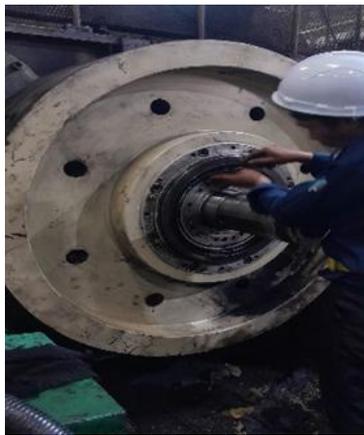
Figure 4. Clutch brake seal before repair

Inspection revealed that the clutch brake seal had been improperly installed, resulting in misalignment and uneven contact surfaces. This condition caused continuous oil leakage from the clutch brake system (Figure 4), leading to lubrication failure and accelerated wear of internal components. Corrective actions included seal replacement and precise reinstatement in accordance with manufacturer specifications (Said, 2023; Nasution & Lukman, 2024). After repair, oil leakage was eliminated and sealing performance was fully restored (Figure 5).

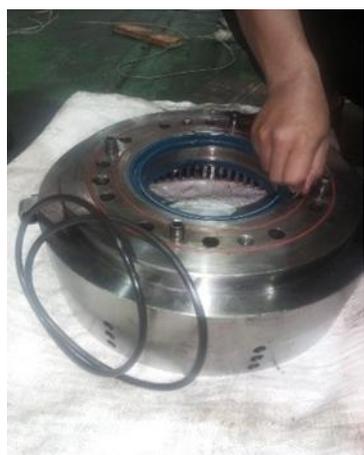
Figure 6. O-ring before replacement

The O-ring located in the clutch brake housing cover exhibited clear signs of aging and embrittlement (Figure 6). Material degradation reduced its elasticity, compromising sealing effectiveness and increasing the risk of oil leakage (Said, 2023; Nasution & Lukman, 2024).
