Case Study of Decreasing of Quality of Processed Waste at Sewage Treatment Plant to Contain Waste Disposal on Ship Mv. Ck Angie

Charry A. Pasaribu¹, Markus Yando², Damoyanto P³

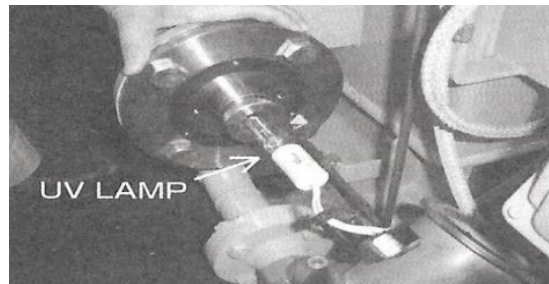
Figure 1. UV Lamp

Cause identification: The UV lamp is not working effectively. The UV lamp on the UV sterilizer functions as a source of ultraviolet (UV) light which can kill microorganisms such as bacteria, viruses and fungi in water or other liquids. From the results of the analysis it was found that the light conditions of the UV lamp were dim, so that the bacteria could not be sterilized using ultraviolet light.

The way to deal with a UV lamp that doesn't work effectively is to replace the UV lamp based on running hours (running hours of a UV lamp 8,760 hours or 1 year for continuous use).

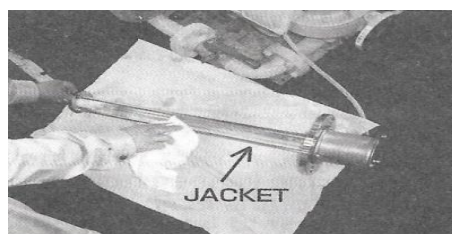
Figure 2. Jacket UV sterilizer

Dirty UV jacket sterilizer. The jacket on the UV sterilizer functions to maximize the effectiveness of ultraviolet (UV) rays in killing microorganisms in water or liquids. This transparent glass jacket or tube protects the UV lamp from contamination or damage. The jacket on the UV sterilizer is designed to block UV rays and extend the contact time between UV rays and water or liquids to be sterilized. By blocking UV rays, the jacket can ensure that water or liquids passing through the UV sterilizer are exposed to UV rays of sufficient intensity to kill microorganisms. From the results of the analysis it was found that the condition of the UV sterilizer jacket was dirty so that the ultraviolet rays could not function optimally.

The way to deal with dirty UV jackets is to clean the UV jackets regularly by implementing a regular planned maintenance system (PMS).
