## Analysis of Thermite Rail Joint Damage in Curve Section 3 of Lrt Jakarta

**Abstract:** This study analyzes the damage to the Alumino Thermit Welding (ATW) rail joints in the curved Section 3 between Pulomas Station and Boulevard Selatan Station of the Jakarta LRT. Using a qualitative method with a cause-and-effect approach through a fishbone diagram, the study identifies the factors causing the damage. The results show that the damage is classified as Surface Defect. The primary contributing factors are the small curve radius, imbalance of train wheels, and the driving technique of the train operator, with the highest frequency at 46.15%. This is followed by inspections conducted only visually at night with limited lighting, contributing 38.46%. Material factors have the smallest contribution, at 15.38%. For repairs, it is recommended to use methods such as patching with electric welding, grinding, and re-welding, along with routine inspections using Ultrasonic Testing. Coordination with the OCC and Crew Unit Leaders (train operators) regarding the recommended speed limits on curves is crucial, and the implementation of sensor technology for real-time monitoring of rail conditi

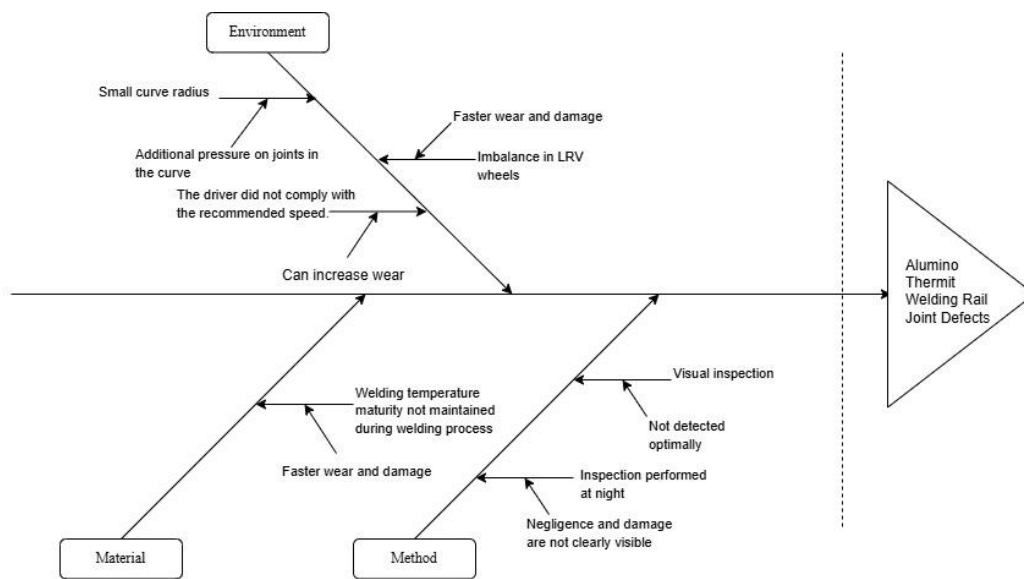
**Fig 1. Diagram Fishbone**

Based on the fishbone analysis diagram that has been made, it can be seen that with this fishbone analysis theory, namely by identifying and finding various causes of problems related to damage to Alumino Thermit Welding rail joints. It can be determined that the main cause that causes damage to the Alumino Thermit Welding (ATW) rail connection on the section 3 curve of the Pulomas Station plot - South Boulevard Station of the Jakarta LRT, namely:

1. Weld maturity and temperature control, greatly affect the durability of the joint. Imperfections in these processes can lead to structural weaknesses that accelerate damage, especially in curved areas.
2. Inspections were conducted only visually and were conducted at night under limited lighting conditions, potentially missing damage or minor changes to the joints.
3. Driver non-compliance with the recommended speed when crossing rail curves is a significant factor. Speeds in excess of recommended limits can increase stress and wear on rail joints, accelerating the onset of damage.
4. Operational conditions such as too small a curve radius and train wheel imbalance put additional stress on the rail joints.

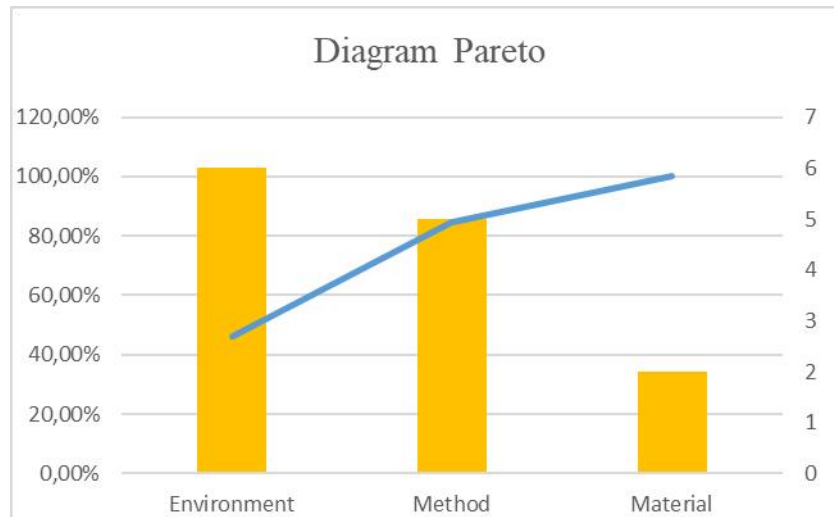
**Fig 2. Diagram Pareto**

The frequency of causes of damage is based on data collected from interviews with several informants. The following is a detailed explanation of the diagram:

1. Environment has the highest frequency (6), which means this factor is the main cause of the analyzed problem. It accounts for about 46.15% of the total occurrences.
2. Method is the second most significant factor, with a frequency of 5, which accounts for 38.46% of the total occurrences.
3. Material has the lowest frequency (2), and accounts for 15.38% of the total occurrences. The cumulative line shows that by improving the Environment and Method aspects, about 84.61% of the problems can be solved. Therefore, improvement measures should focus on these two factors to get the most significant results.
