## Analysis of Damage to the Axle Counter of the ZP D 43 Module at the Maros Station Crossing

**Abstract:** This study analyzed the damage to the Axle Counter Module ZP D 43 at the Maros Station crossing. The ZP D 43 module functions to detect the presence of the train, but it was found to be disrupted due to lightning strikes and a poor grounding system, which caused fatal damage to the module and counting head. The research method uses a qualitative approach through observation, technician interviews, as well as SWOT and TWOS analysis. The results of the SWOT and TOWS analyses show the need to improve system protection and grounding improvements to improve operational reliability. These findings provide strategic recommendations to improve the safety and efficiency of train travel in the Makassar–Parepare Railway Project.

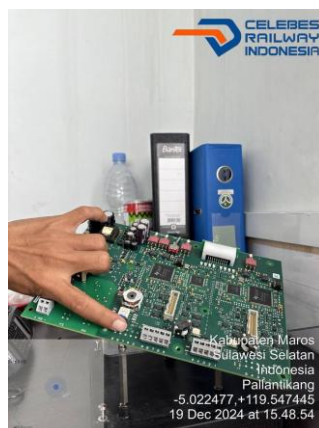
**Figure 1. Documentation of the Discovery of the Burning ZP D 43 Module**

After data collection in the form of interviews, based on the frequency of time damage to the Axle counter is not as frequent as once every few months, but occasionally there is a red track due to fault errors in the ZP module, The cause of the red track on the VDU (*Visual Display Unit*) display is often due to a bad cable joint on the track, not good here means connecting but the voltage goes up and down or is not fixed. And the solution to this is none other than to connect the cable using a spare cable. So when there are wires there is nothing good. This means that it is necessary to find and disassemble the joint and then repair it, but one of the latest anomalies that occurred on December 19, 2024 on ZP D 43 was damaged due to lightning strikes that required a total replacement of the ZP D 43 module.

It can be concluded from the picture above, there is an indication of a report from the field officer who reported that the indication of ZP0413 on the ACM is orange which means that there is a problem of damage to the ZP D 43 module, which causes the TCB Module as a counting head to be damaged. The image above shows the ZP Module which is allegedly struck by lightning, Lightning is a flash of light in the atmosphere that consists of thunder and is caused by the release of electricity. Lightning is generated in electrically charged storm systems (Mudhalifana, 2016). According to data from BMKG on lightning strike information on Sulawesi Island during January 2025, the Total CG (*Cloud to ground*) Lightning Strike varies greatly. The total number of CG strikes in January 2025 decreased slightly when compared to December 2024. This strengthens the assumption of a lightning strike that occurred right at the time the Axle counter was suspected of a lightning strike. When a lightning strike occurs in the transmission line, an overvoltage occurs, causing ground disturbance and insulation failure (*back flashover*). This *flashover* phenomenon occurs when the voltage across the insulator line exceeds the critical voltage of *the flashover*, causing a fire crack in the insulator (Pangestu, 2020). The insulating device in this case is the grounding system on the Axle counter. Actually, it did not hit the ZP module directly, but the affected rail then spread to the *counting head*, from the *counting head* it propagated to the ZP D 43 module that was hit by lightning, it was found that the module and counting head were damaged" from the results of interviews from technicians in the field. For the Axle counter module, it can actually be repaired here, but it depends on the damage. For example, a small device attached to the module with this soldering method can still be combed or repaired, while in this case the ZP module which is considered "burned" due to the propagation of lightning strikes must replace all units, especially the TCB module of the ZP module. The following is the technical data of the ZP D 43 device:

From all the data we collected, it can be concluded that the solution to the case of the ZP D 43 module being struck by lightning is to pay attention to the good grounding aspect, namely each rail and around the axle counter and money order. From the results of the above findings, it can be concluded that several factors can be concluded for the formation of a SWOT analysis of the cases that occurred. Here is the SWOT analysis table we created:

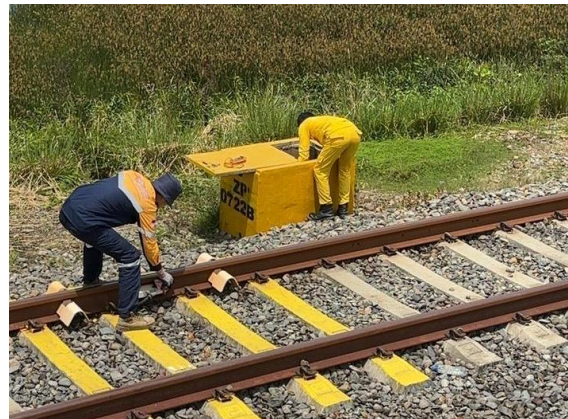
**Figure 2. Deflector Components**

From the description of the table above, it can be concluded that the input voltage to the module itself is in the form of DC, and there is equipment that functions to protect the counting head in the form of a *deflector* located next to the ZP module. As a physical protector of the counting head, on the other hand the protection of the counting head component from overvoltage, namely the grounding system, in this case *the deflector* which is also an electrical conductor, it can be ensured that the lightning strike that propagates through the rail is passed through *the deflector* which is also made of metal. The standard of good grounding resistance is below 5 ohms according to PUIL, The relationship between resistance (resistance) and current and voltage was discovered by a physicist named George Simon Ohm. Ohm found that the value of current is affected by voltage and resistance (resistance) Insulation must be measured because the insulation value of an object can change due to the influence of outside weather and the structure of the material itself. The external influence is where the Insulation is located, whether in a humid room or in a place with high
