Evaluating the Hydraulic Performance of Existing Water Supply Distribution System: The Case of Tebela Town of Wolaita Zone, Southern Ethiopia

Zerihun Tefera Toma[1]*, Mhiret Dananto[2]
[1] Hawassa University, Hawassa, Ethiopia, email: mamezerihun@gmail.com
[2] Hawassa University, Hawassa, Ethiopia, email: myadssa2004@yahoo.com

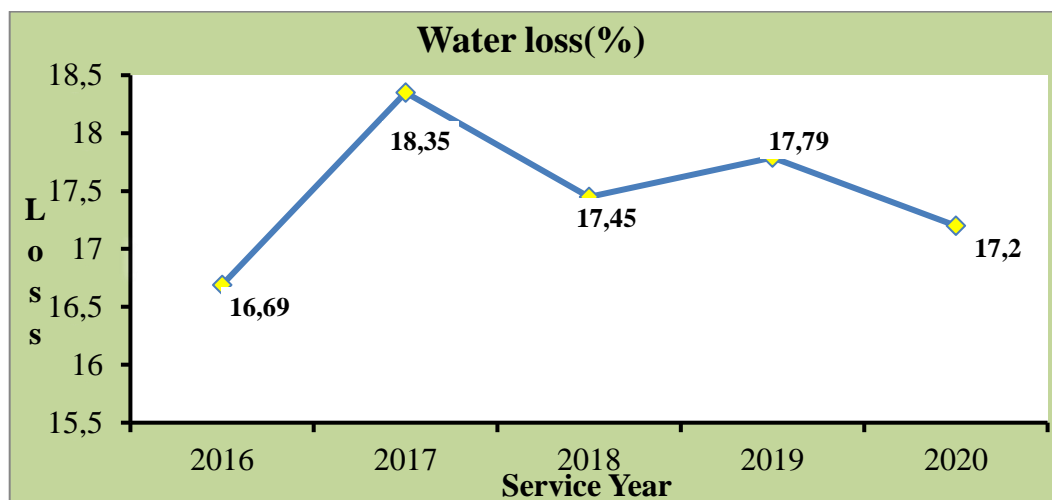
Figure 3. Water losses in percentage

Water loss from water distribution systems (WDSs) has long been a feature of water distribution system operations management. According to figure 3.2, the water loss in 2020 (17.2%) is less than 2019 (17.79%) due to pump, pipe and fitting maintenance. The average amount of water, which actually reaches the consumers, therefore, accounts for only 82.8% of the total water produced. According to (Mckenzie et al., 2006), the system efficiency is good (acceptable) if above 75% of water produced reaches the consumer. Thus, Tebela town water supply system is good (acceptable).

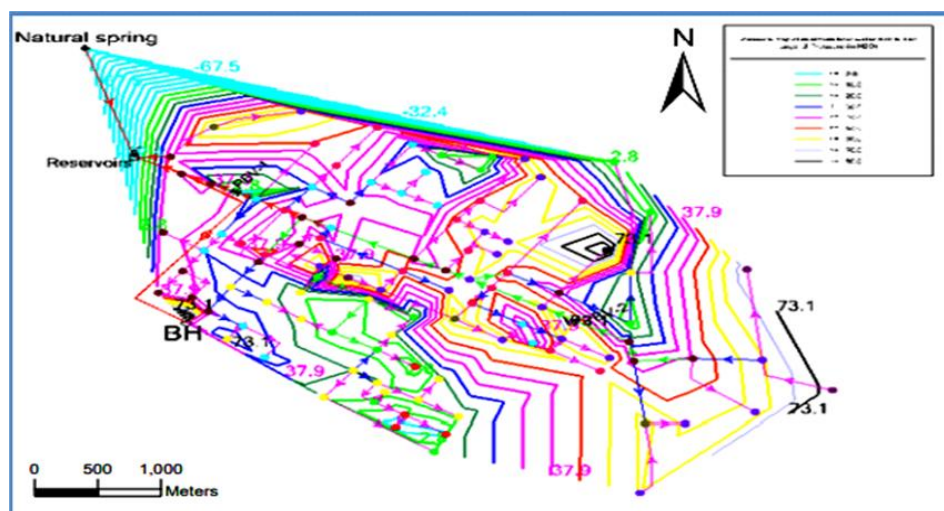
Figure 6. Pressure contour map of Tebela town at minimum hourly consumption

As shown in table 6 above, 3.77% of the nodes are under desirable minimum pressure and 1.89% of the nodes are exceeding maximum allowable pressure during minimum hour consumption. There is no negative pressure during a minimum consumption time, while, 94.34% of the nodes are in the permissible pressure range of a

minimum of 15m and a maximum of 70m. However, 1.89% of the nodes were getting water above standard pressure (>70m) due to low consumption at midnight when most of the consumers are sleeping and not using water. Higher pressure may cause the pipe to burst.

The best operational practice to optimize the operation of the water distribution system was to control the pressure in the network. This management of pressure has been reflected in the aspect of reducing excessive pressure by installing a pressure reduction valve. By controlling the pressure, it is possible to reduce the amount of water loss from the system, the occurrence of internal damage, and power consumption related to high pressure at a minimum hourly demand pressure was high at lower elevation areas. Installing pressure-reduced valves around Humbo St.George Church at junction (J-17) and Mehal Kebele area at junction (J-88) links that have maximum pressure was used to reduce excessive pressure to the desired allowable value seen in the table below.

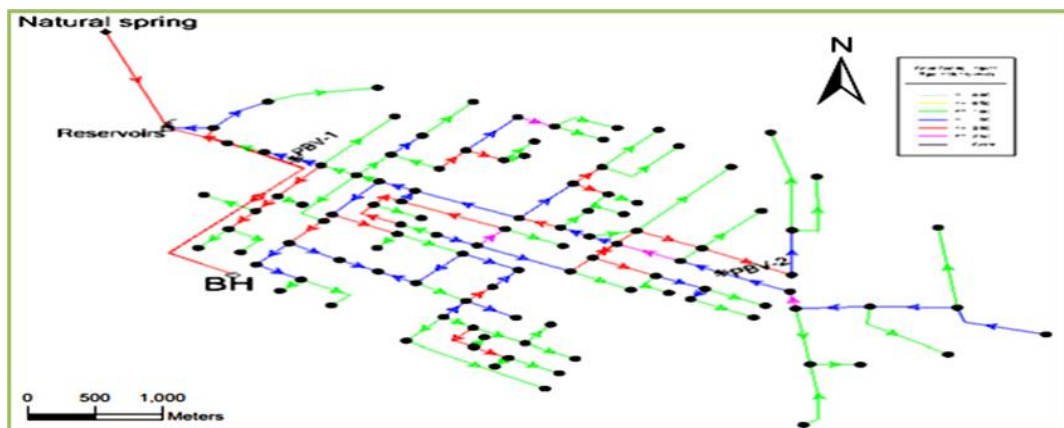
Figure 7. Velocity for water supply distribution network during peak hour consumption

As indicated in table 7 above, 0.85% of the pipes are below the desirable minimum velocity and 3.42% of the pipes are exceeding the maximum allowable velocity during peak hour consumption. While 95.73% of the pipes are in the recommended velocity range of minimum 0.6 m/s and maximum 2 m/s velocities. In this study area, 4.27% of the velocity is not in a suitable range based on Ethiopia's urban water supply design guideline criteria.

Increasing the diameter of the pipe in a water distribution model results in a corresponding decrease in velocity and an increase in pressure. At peak hour consumption, the velocities outside of the design range are modified by resizing the pipe diameter. The pipe which does not meet the allowable minimum and maximum velocity was selected for modification to improve the water distribution system.

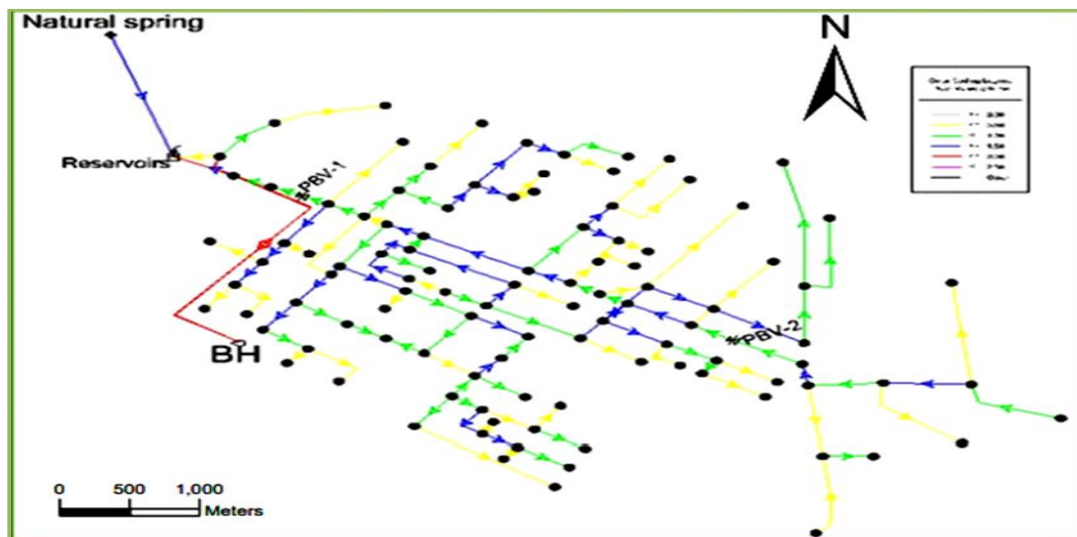
Figure 8. Velocity for water supply distribution network during minimum hour consumption.

As shown in table 8 above, 34.18% of the pipe was below the desirable minimum velocity and no pipe velocity exceeded the maximum allowable velocity during low consumption time. While 65.81% of the pipes are in the recommended velocity range of minimum 0.6 m/s and maximum 2 m/s velocities. In this study area, 34.18% of the velocity is not in a suitable range based on Ethiopia's urban water supply design guideline criteria. There is no head loss and water hammer in this study area during the minimum consumption time.

Generally, the town's water distribution system's velocity was inadequate since velocity in major pipe parts during the minimum consumption time and peak hour consumption, as shown in figures (7) and (8). Therefore, control of the flow velocity in water distribution networks should be maintained in order to avoid pipe breaks, water hammer, and water stagnation which cause sediment deposition in the pipe and head loss.
